So your 1100 Shadow has started dripping oil everywhere; maybe a few drops, maybe even a small puddle. Crawling underneath, you find the oil seems to be coming from the radiator hose. What's going on? You my friend, may have just found the little-known problem with Honda's guide plug design on the single-pin crank engine.

This document describes a temporary patch that takes about 30 minutes, has proven effective for over 1,000 miles (but no more than 1,300 miles) and can be repeated until there is time to invest in the repair. **Disclaimer:** This is a temporary patch and should not be considered a solution to the guide plug oil leak. Use these directions at your own risk.

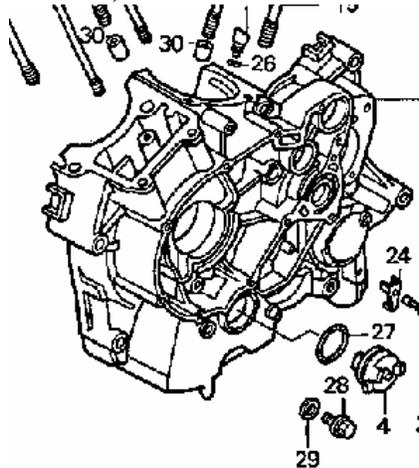
The guide plug (Honda part number 11211-MK7-770) fills an access port to keep the oil from leaking. It's in the Honda parts microfiche shown as number 4 on the crankcase illustration and has an O-ring seal (number 27 in the illustration; part number 91351-MG7-004).

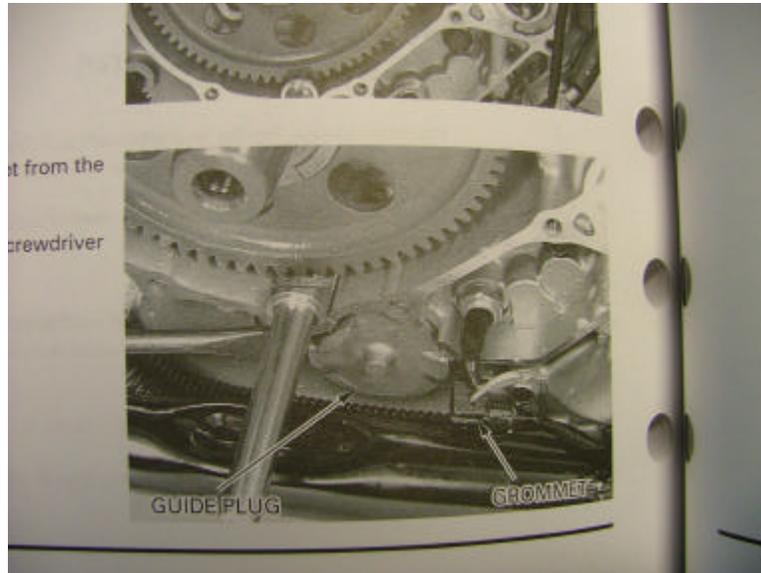
The guide plug is shown in the shop manual with the engine removed from the frame and the left crankcase cover removed. (You'll find this illustration in the "ELECTRIC STARTER/STARTER CLUTCH" chapter in the "STARTER DRIVEN GEAR/STARTER CLUTCH REMOVAL" section.)

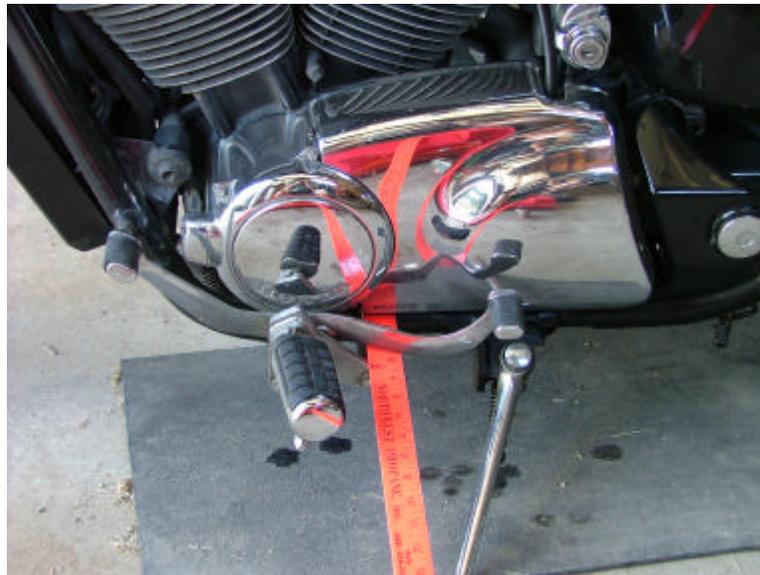
It's a little bit harder to find it on the bike. Start by following the yardstick to see where the guide plug is on my bike.

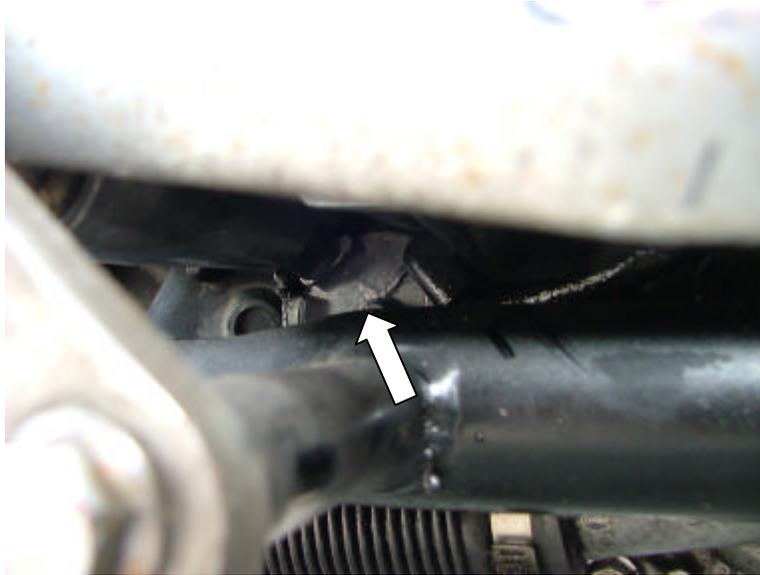
There it is, just barely visible from the side of the bike.

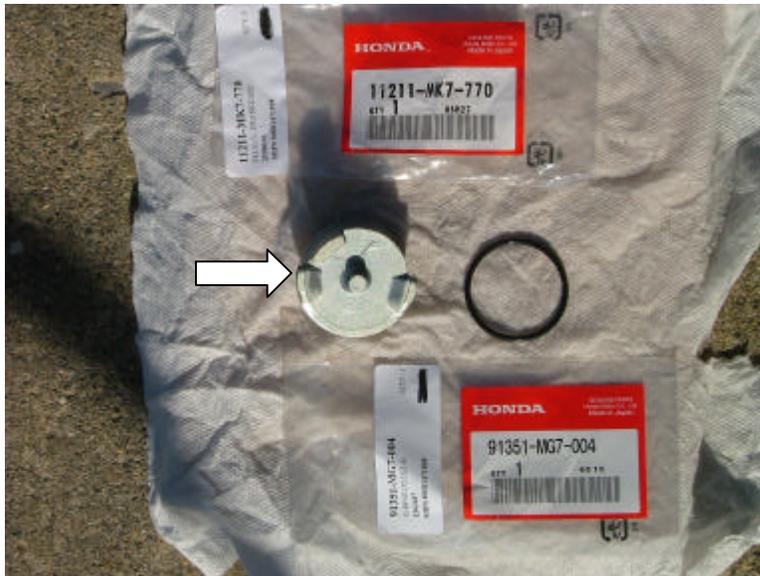
Here's what a new one looks like:

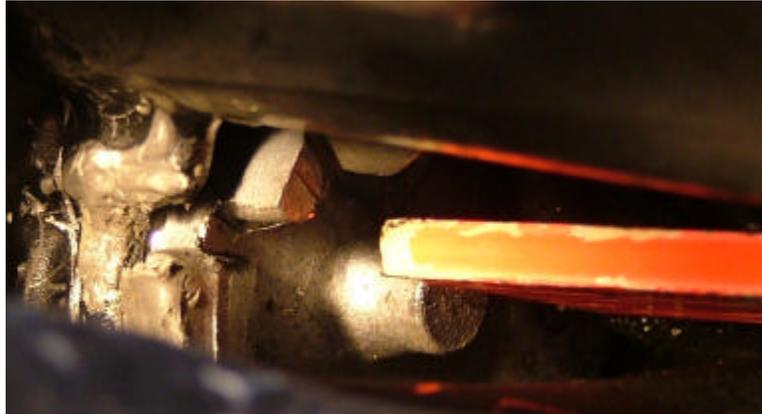
(Note the JB Weld from the previous patch operation.)

- a. From the side of the bike, use the yardstick (or a long screwdriver if you prefer) to gently push the guide plug back into the crankcase.

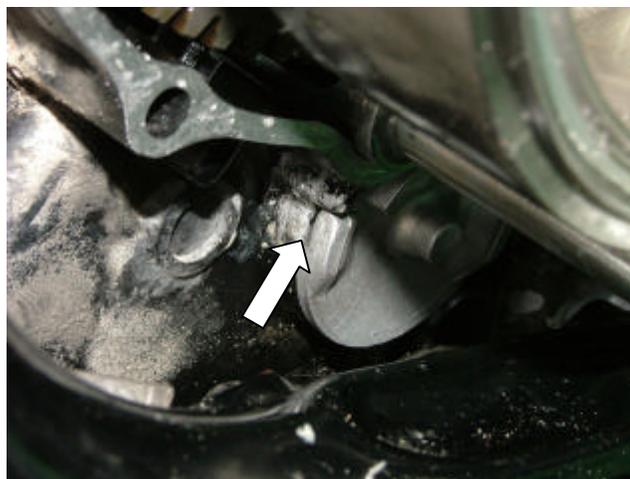
- c. Check for proper position; you should see a small notch between the guide plug and the crankcase.

(Note that this picture was taken with the crankcase cover removed, the "old" JB Weld cleaned up and a new guide plug.)
